MONITORING LEANING OF ALHADBA MINARET

Dr. Rasheed Saleem Abed
Remote Sensing Centre
University of Mosul \ Iraq
mosul_5@yahoo.com

Abstract:

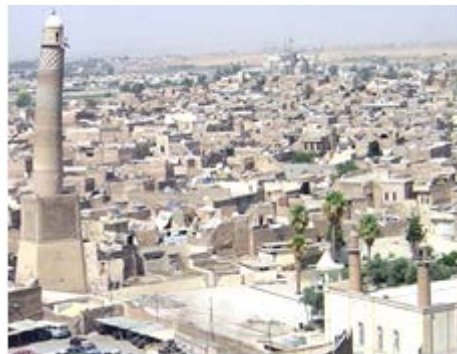
Figure 1. Alhadba, a focus area within the old city of Mosul.

- 1- Particular leaning of the minaret.
- 2- Noticeable height (50 m) and age as compared to the nearby old city housings. See figure 1.
- 3- Resistance to centuries of deterioration due to weather, quakes, and human disturbance around the minaret.
- 4- Documentation of cultural heritage.
- 5- Preparation for restoration, maintenance, protection and safety.

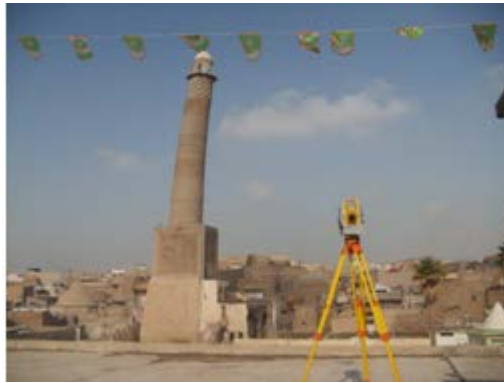
The instrument can be operated in the reflectorless automatic scanning mode to produce point cloud of targets in three dimensions.

Figure 2. Topcon Imaging Station at monitoring work.

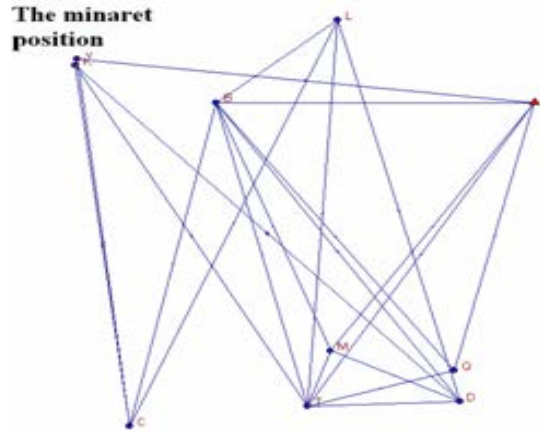
Figure 3. Network of control points.

Point (A), is the major control point fixed into the garden at about 70 m from the minaret base. It approximately faces the eastern convex side of the leaning body along the leaning line. Most of control points in fig.3 are not proposed for actual monitoring in the future. They are adopted only at this early stage in order to strengthen the network configuration and increase precision of coordinate measurements using least squares solutions. Some of these control points can not be used for setting up monitoring instruments. They are used for orientation of instruments during setting up.

Points D, Q are fixed on the (rigid) concrete ceiling of the mosque. They are stable and face clearly key target points on the trunk of the minaret. Using epoxy adhesive, at each point a steel bolt is fixed into a small hole drilled into the concrete roof. The bolt head have been treated against corrosion and a small point have been marked in the center of the head for precise setting of surveying instruments.

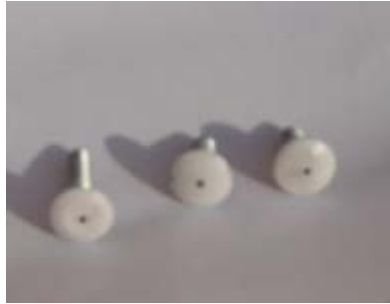
Targets are made of steel bolts of 2 cm head diameter worked using turning machine. The head was rounded and a small hole mark of 1 mm diameter was drilled in the head center representing the exact monitored mark. Bolts are white painted. See figure 4. A high crane was used to fix these targets and great care was taken in order not to hit the minaret surface or make any destruction as seen in figure 5. A bore hole of about 4 cm deep was drilled into the wall of the minaret, cleaned and filled with epoxy adhesive. Finally, the steel bolt pressed into place.

Figure 4. Steel bolts prepared as targets.

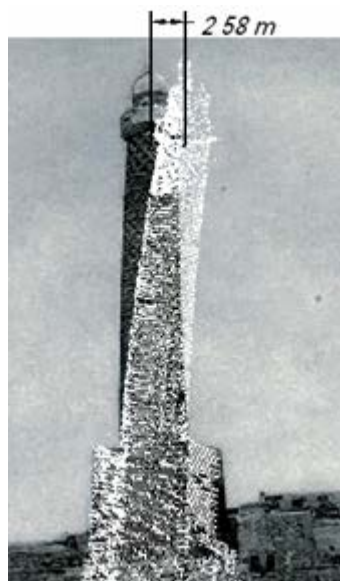
Two sets of data have been compared to predict the history of amount of leaning using photogrammetry. First, an old photograph of the minaret probably dated back to year 1925 have been analyzed. The second set resembles a 3D representation of the minaret prepared using the scanning capability of the IS-203 instrument. In order to make realistic comparison, care was taken to estimate the location of the shooting camera in order to orient the two data sets into same alignment as much as possible. Figure 10 shows the overlay of the two sets and amount of leaning. From this overlay, the author expects that during the last 90 years, there was a considerable leaning movement of the upper points of the minaret that amounts to more than 2.5 m eastwards. The prismatic base overlay doesn't coincide well due to base tilt as shown earlier un figure 7. The author argues that the major part of leaning of the minaret have been occurred during the last century.

Figure 10. Estimated leaning during the last 90 years.
